The Military Engineer

PRESERVING HISTORY THROUGH DESIGN-BUILD

While there are challenges in applying design-build to historic renovation projects, the right partnership and processes can overcome them, leaving the positive benefits that attract owners and contractors to this delivery method.

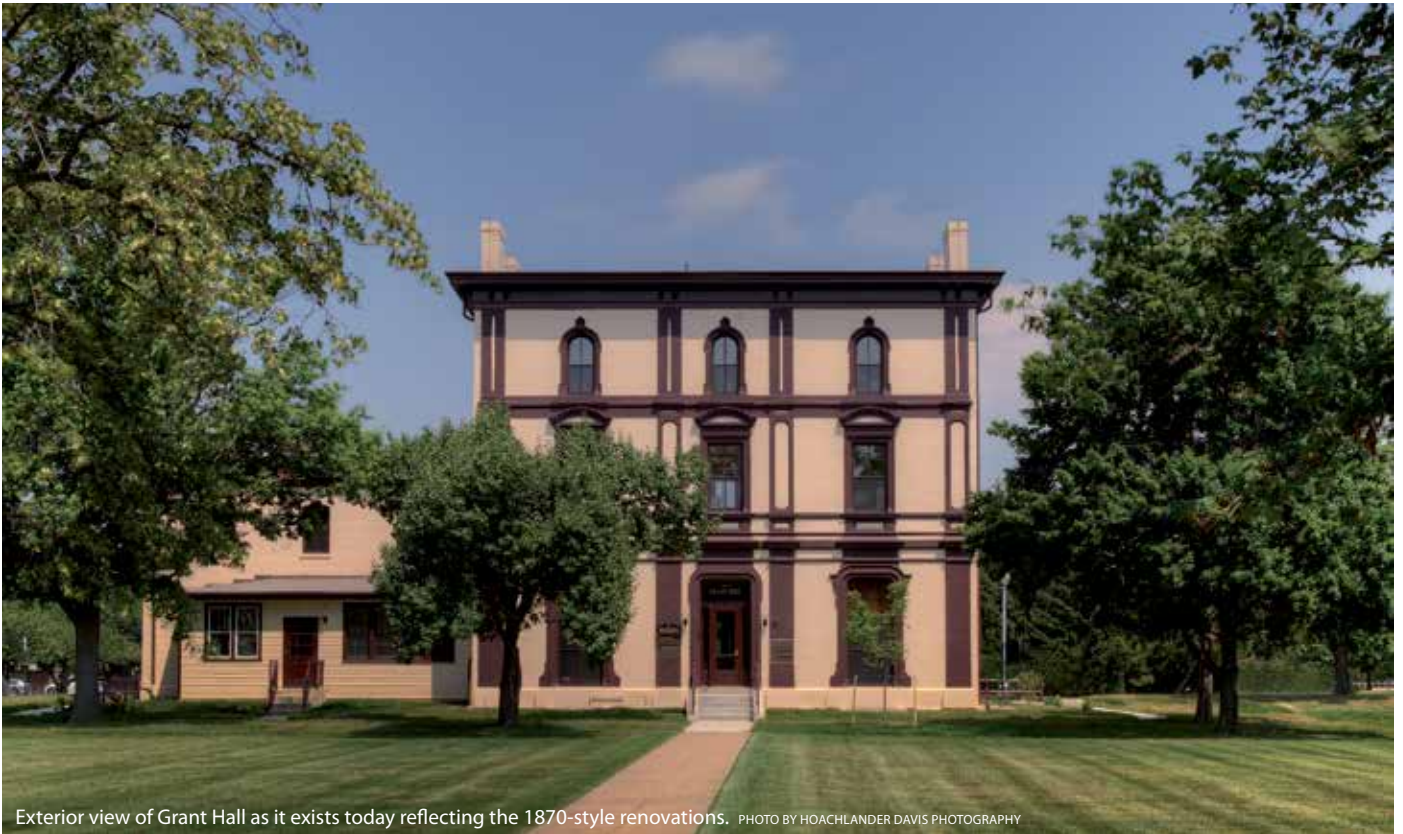
Exterior view of Grant Hall as it exists today reflecting the 1870-style renovations. PHOTO BY HOACHLANDER DAVIS PHOTOGRAPHY

Grant Hall, located on the grounds of Fort McNair in southeast Washington, D.C., is a remarkable story of survival. Constructed around 1832 as an extension of the Federal Penitentiary built in 1829, the building played a key role in American history. From May 9–June 30, 1865, a Military Tribunal convened on the third floor of Grant Hall in judgement of the eight conspirators arrested in the assassination of President Lincoln. Just five years later in 1870, the exterior and interior of the building were radically altered to reuse the building as officers' housing, turning the Georgian revival penitentiary into an Italianate residential structure.

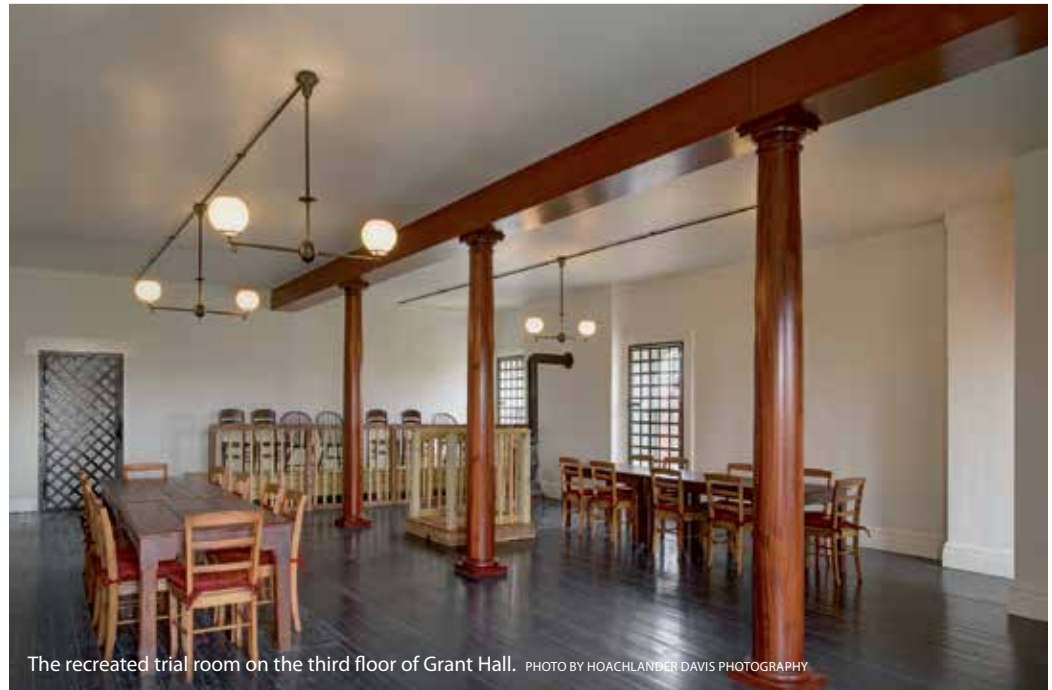
The recreated trial room on the third floor of Grant Hall. PHOTO BY HOACHLANDER DAVIS PHOTOGRAPHY

contractor Polu Kai Services to renovate Grant Hall. Overseen by the Baltimore District of the U.S. Army Corps of Engineers, the project included recapturing the 1865 appearance of the third-floor trial room. The design-build team was provided a set of bridging documents that provided a schematic level of design. A critical element of the third-floor design was “reclaiming” a series of columns that bifurcated the trial room, visible in period lithographs. When the team visited the space prior to submitting the proposal, concerns were raised about the accuracy of the proposed design in the bridging documents, particularly as it related to the location of the columns and the potential structural implications.

Discussions with the owner revealed that the team which developed the bridging documents was offered limited access to the building for investigative purposes. This gap in detailed physical analysis required them to make assumptions, including that the columns were buried in an 1870 masonry wall. When the EYP-Polu Kai team submitted its proposal, a budget item was included for research and investigative removals to confirm the final design.

Based on research, the team believed that the columns were not located in the line of the masonry wall and to recreate them would require structural modifications to both the floor and roof impacting the cost of the construction. A benefit of working as a design-build team was that EYP-Polu Kai could self-perform the investigative removals quickly and cost effectively. Ultimately, the findings confirmed the position regarding the location of the columns. A revised schematic design, including structural modifications, was developed and submitted for review with a modified cost proposal. Working with the owner, the team then was able to evaluate the scope and approach to the entire project, allowing the reconstruction of the trial room to be accomplished within the original budget.

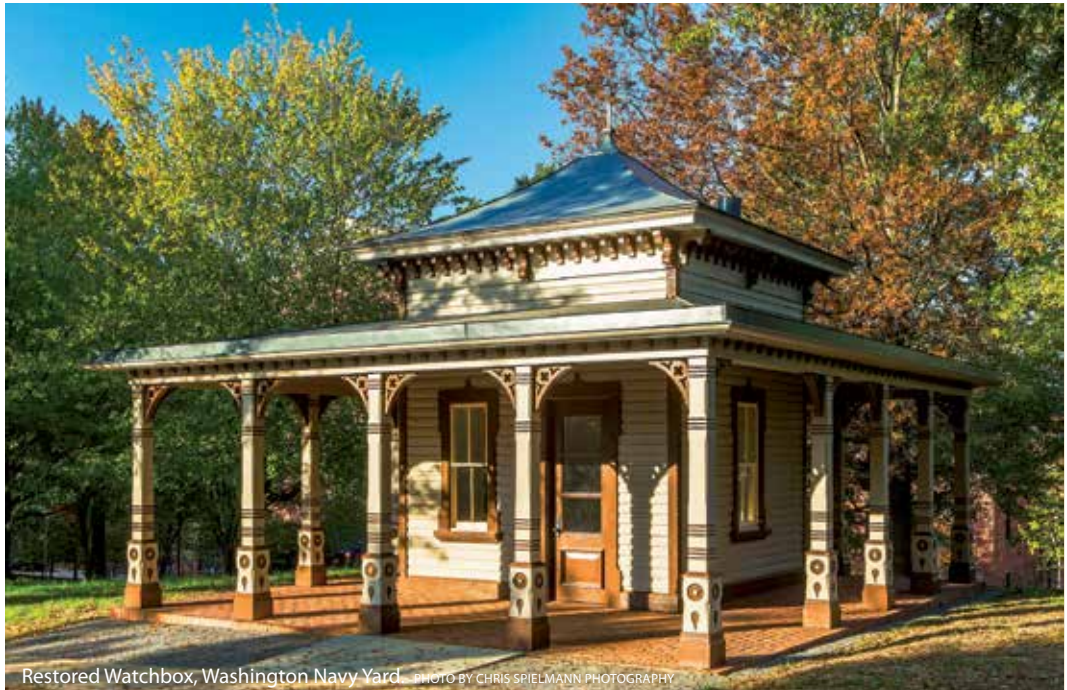
Restored Watchbox, Washington Navy Yard. PHOTO BY CHRIS SPIELMANN PHOTOGRAPHY

The restoration scope was based on historic photographs and limited evaluation of the surviving portion of the building. The narrative scope included a new foundation at the Navy Yard, carefully moving the Watchbox back up river, set in place, the porch reconstructed and the exterior repaired and repainted. Summit Construction, in submitting the proposal for the much larger pier project, had included a line item cost for the Watchbox based on the narrative scope.

When EYP was engaged, the proposal included evaluation of the surviving building fabric to correlate the physical evidence with the historic photographs and narrative scope. The evaluation identified two aspects of the building that varied from the restoration scope. First, the door and window openings had been moved on two of the elevations. Second, the existing flooring and structure were a

later modification and did not exist at the Navy Yard. A summary report and a revised schematic design proposal was developed by and submitted to Naval Facilities Engineering Command for review and to be shared with the State Historic Preservation Offices in both Maryland and the District of Columbia. All the review authorities approved the adjusted design.

By October 2015 the historic Watchbox had been carefully floated back up the Potomac and reinstated as part of the Washington Navy Yard, just over 100 years after it had departed.
